## Altstadtringtunnel München

### SHORT DESCRIPTION

In the course of preliminary investigations for a planned repair of the Altstadtring Tunnel, the material properties of the built-in prestressing steel should be determined.

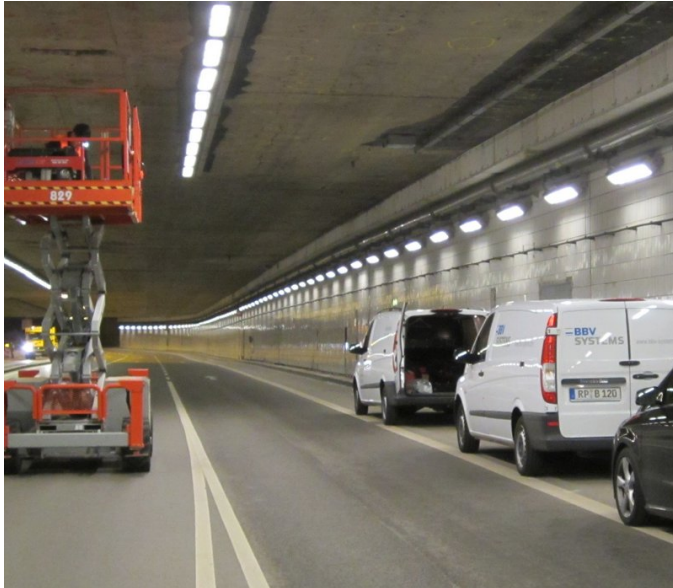
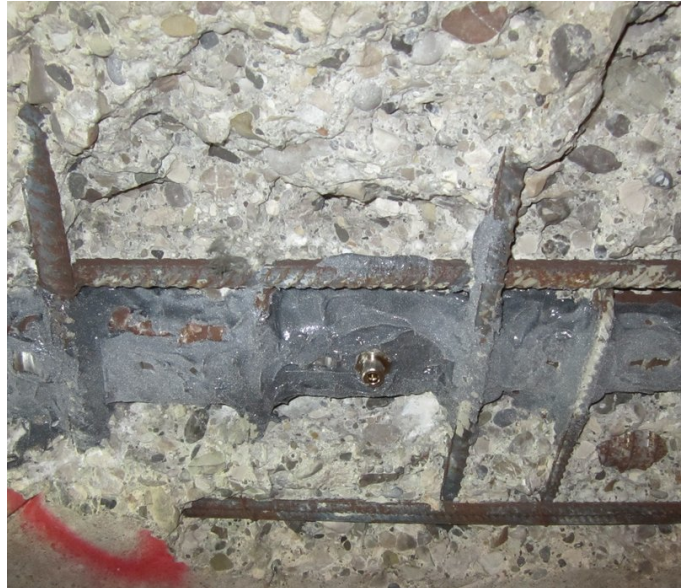
For the prestressing steel test, the accompanying engineering office had openings made on the ceiling of the Altstadtring tunnel using high pressure water jets. The structural concrete, the cladding tube and the cement glue inside the cladding tube were removed.

To create a compressible space, cladding tube half-shells were attached to the existing, separated cladding tube ends and injection openings were made in the cladding tube half-shells. After completion and sealing of the half-shells, the sections

to be pressed were checked for leaks and at the same time the volume to be pressed was determined. To create a pressure cushion, all openings were reprofiled with shotcrete. After the sprayed concrete had hardened, it was grouted using the vacuum process.
